Title: Electrorefining Low Yield Possible Root Causes

Author(s): Ewing, Frederic

Electrorefining Low Yield

Possible Root Causes

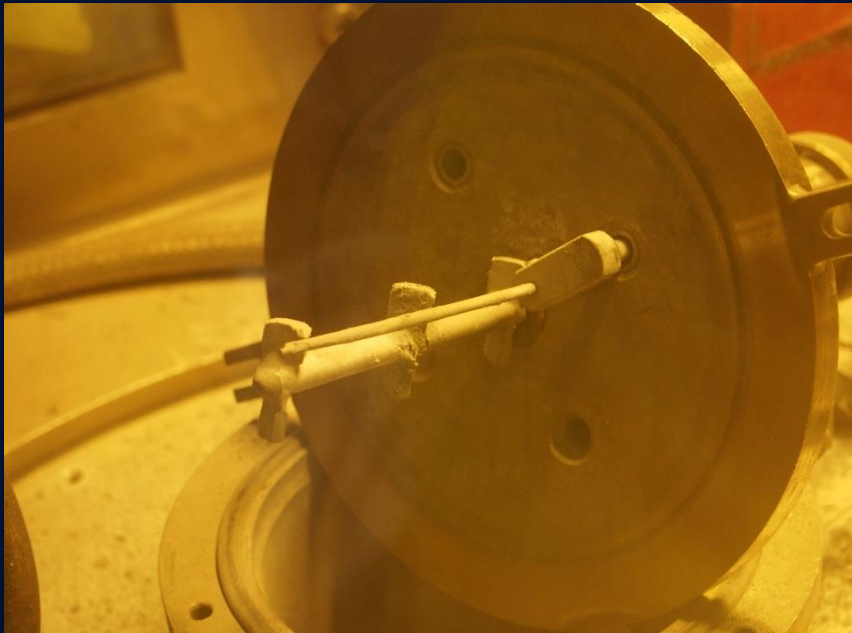
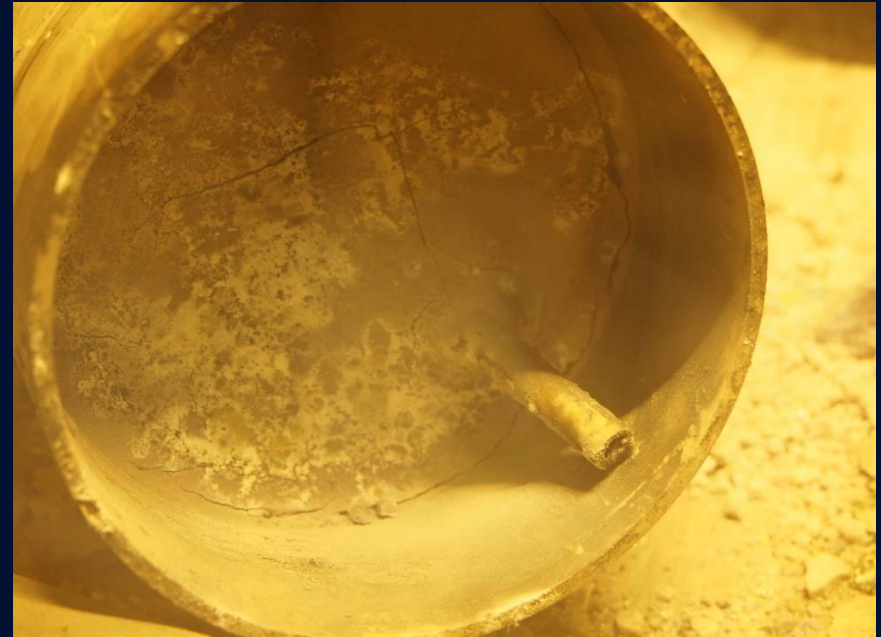
Problem #1: Paddle Falling Off

- Occurring in the majority of runs in the past 5 months.
- Electrode loses contact with the liquid anode pool, passing current directly into electrolyte, prematurely ending run.
- Sometimes, the ceramic sleeve slides off of rod when raising equipment.

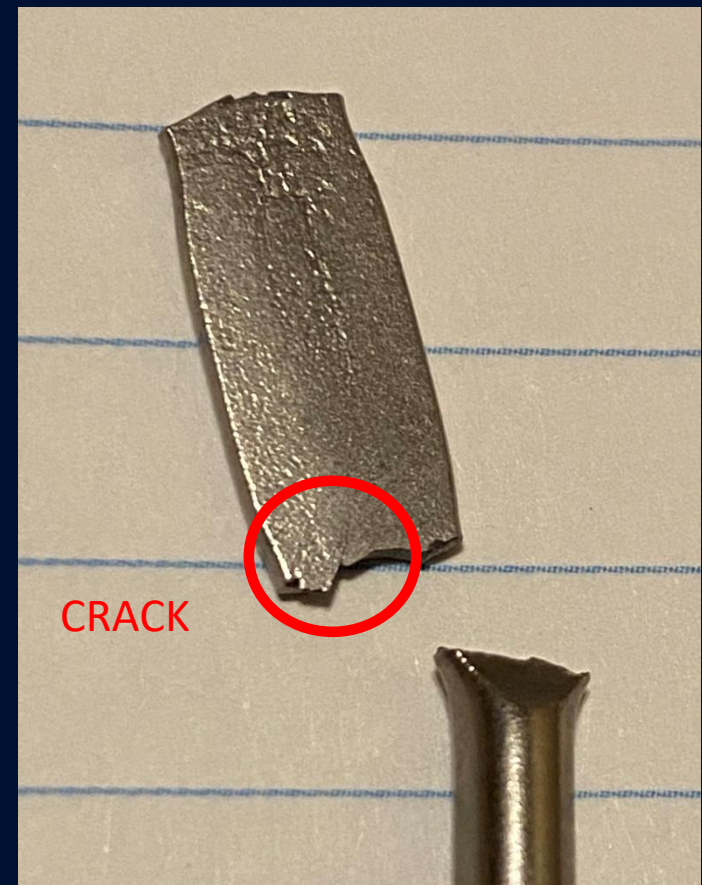
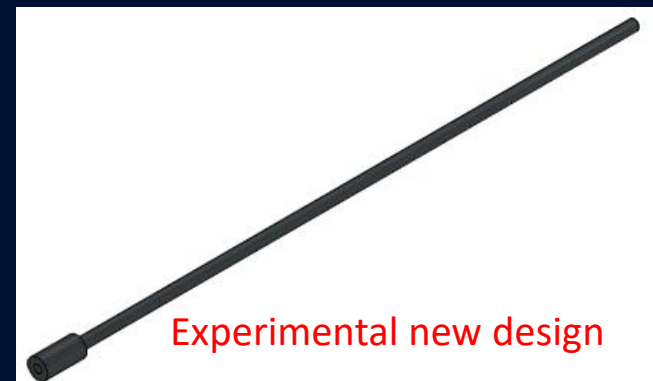
Hypothesis #1

- Tungsten extraordinarily brittle.
- Very difficult to fabricate with.
- If not controlled very carefully, material properties negatively impacted (e.g., ductile to brittle transition temperature increases, grain re-crystallization)

OUR FABRICATION WAS NOT CONTROLLED WELL!

- heated with acetylene torch until “red hot”, leading to grain re-crystallization and brittleness.
- press rate for paddle not controlled, resulting in crack defects.

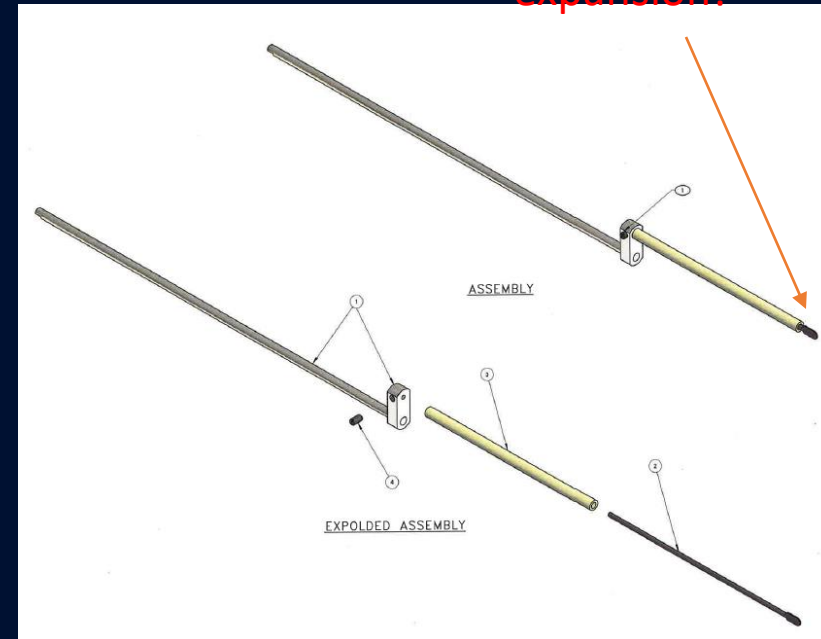
Hypothesis #2

- The anode was lowered into the melt too quickly!
- Thermal gradient induced stresses that fractured the sleeve.
- Thermal expansion coefficient of sleeve is higher than the tungsten. A gap was not left for the sleeve to expand, thus applying stress to sleeve when heated.

-
1. Change procedure to reduce insertion rate to 0.5 inches per minute (per RFP-1876), and specify 0.125-0.25" gap when assembling anode.
 2. Investigating a change from extruded magnesia, which has lower density, to different forming technique.

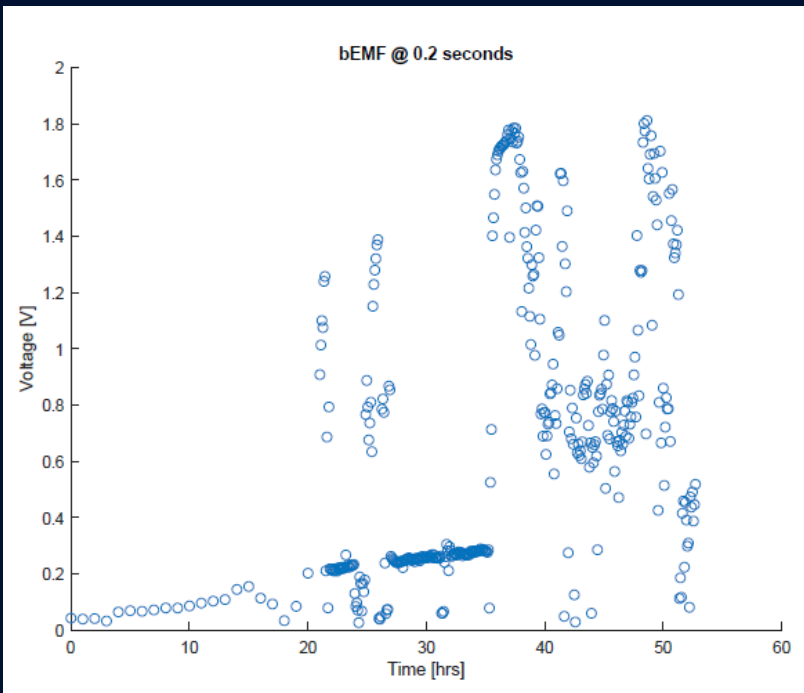
Run from this year

Problem #3: Premature bEMF Ramp Up

-According to ERCS data, bEMF ramps up earlier in run than historical successful run, resulting in early bEMF termination of the run.

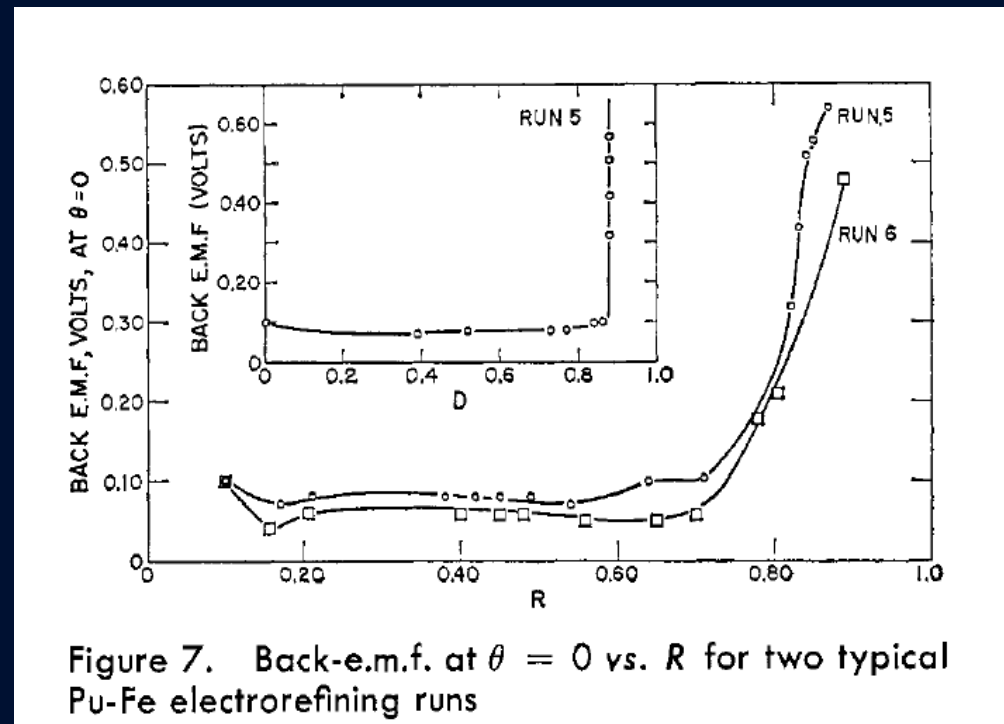
Figure 7. Back-e.m.f. at $\theta = 0$ vs. R for two typical Pu-Fe electrorefining runs

"Textbook" run from 1960s

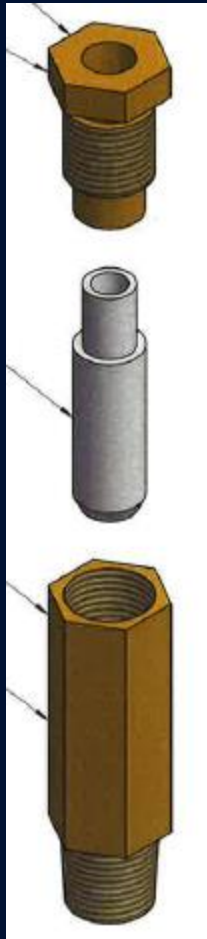
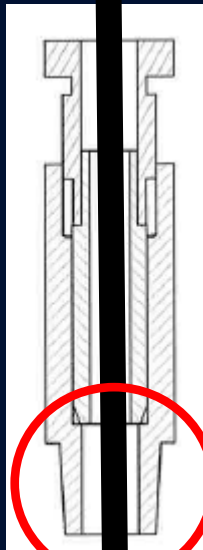
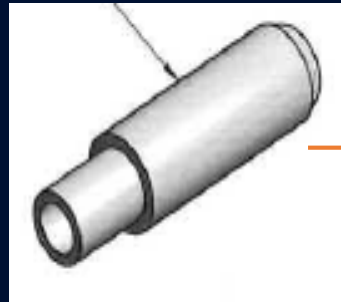
Re-design

- Teflon piece that insulates electrode and holds in place is not long enough.
- As a run progresses, volatiles deposit on the bottom of the cell head where it is cooler.
- Buildup in the seal gland electrically shorts the anode to the cell head.

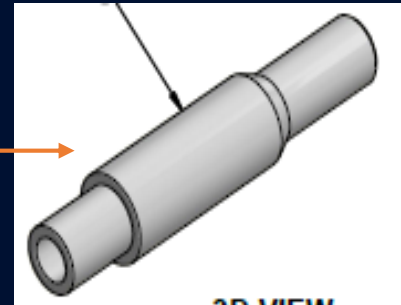
Build-up and short location
